# Field Test Results of an Anti-Scale/Corrosion Resistant Coating for Hot Water Heat Exchangers

Vincent F. Hock, Henry Cardenas, Richard H. Knoll, and Virginia Hall

January 2001

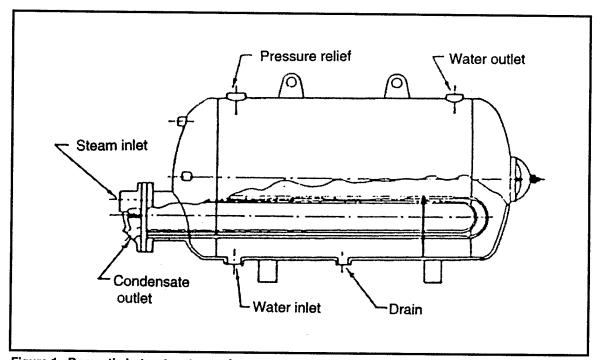
Figure 1. Domestic hot water storage heater.

A heat exchanger system commonly employed in the Army is the DWSH (Figure 1). Such a system is composed of a cylindrical steel reservoir lined with concrete for corrosion protection. An opening at the bottom provides access to a Utube bundle assembly.

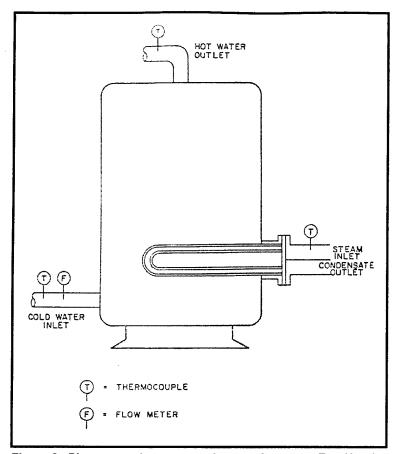
Figure 2. Placement of sensors on heat exchanger at Fort Hood.

Figure 2 shows the placement of the three thermocouples and the flow sensor on a DWSH. The data logger and playback systems can store up to 30 days of data. Data was downloaded to a personal computer once per month for analysis.

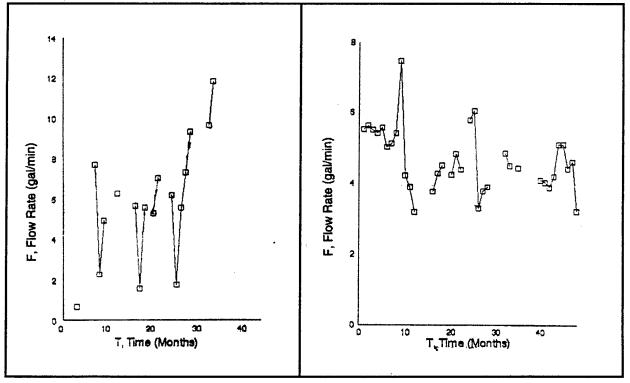
Figure 3. Flow rates (F) for phenolic-coated heat exchanger system in Bldg 29006.

Figures 3 and 4 show the average monthly flow rates (F) over this period. Flow rates for Building 29006 ranged from zero, when the building was shut down, to a recorded maximum of 12 gal/min. As exhibited in the plot, the flow rates fluctuated greatly with building use over the period. While Building 87017 incurred no recorded shutdowns, it also underwent significant fluctuations in use.

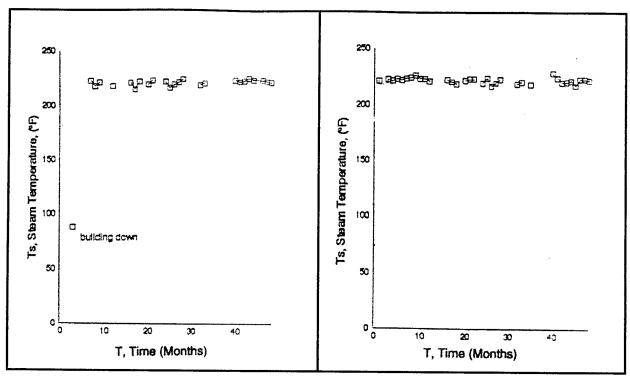
Figure 5. Steam service temperatures (T<sub>s</sub>) for phenolic-coated heat exchanger system in Bldg 29006.

Steam service temperatures ( $T_s$ ) are presented in Figures 5 and 6. The low initial value for Building 29006 again represents a period when the facility was not in use. Apart from this departure, the steam service temperatures measured over this study showed little variation; they were generally recorded in the region of 220 to 225 °F.

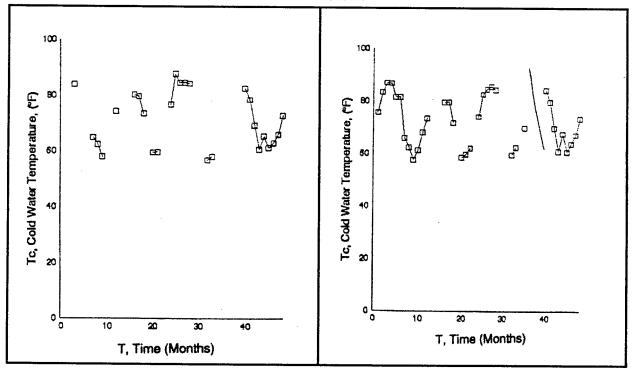
Figure 7. Cold inlet water temperatures (T<sub>c</sub>) for phenolic-coated heat exchanger system in Bldg 29006.

The cold inlet water temperatures ( $T_c$ ) are recorded in Figures 7 and 8. Oscillations were found to follow the seasons somewhat sinusoidally in the range from approximately 55 to 90 °F. This pattern is more apparent for Building 87017 (Figure 8), where more data points were collected, than for Building 29006 (Figure 7).

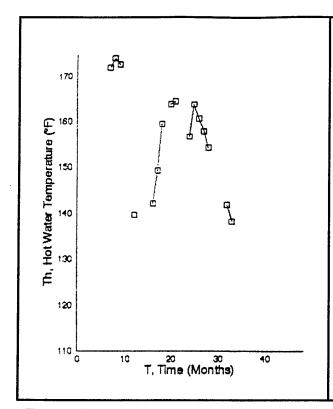
Figure 9. Hot outlet water temperatures (T<sub>h</sub>) for phenolic-coated heat exchanger system in Bldg 29006.

Large fluctuations also characterized the hot water outlet temperatures (Th) (Figures 9 and 10). On two occasions in Building 29006 and once in Building 87017, the water temperature dipped slightly below the 140 °F mark. Average hot water temperatures above 170 °F were recorded for 3 months during the winter of 1988-89 in Building 6. The average hot water temperature approached 170 °F in Building 87017 once during the same winter.

As anticipated, the pattern of the hot water outlet temperatures (Figures 9 and 10) was governed by the pattern of the overall heat transfer coefficients (Figures 11 and 12). In turn, the heat transfer coefficient pattern was governed by the flow rates (Figures 3 and 4). Since the flow rates (Figures 5 and 6) were by far the most erratic aspect of the heat exchanger systems, it follows that these patterns dominated the pattern of values of the heat transfer coefficients (Figures 11 and 12).

However, there is no indication of a negative sloping trend in the hot water outlet patterns (Figures 9 and 10). In addition, the average hot water temperature was consistently maintained at or above 137  $^{\circ}$ F. These observations indicate that scale has not formed on the coated tube bundles in either building.

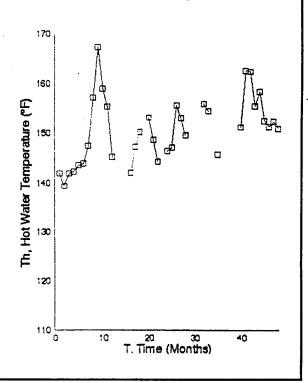
Figure 10. Hot outlet water temperatures (T<sub>h</sub>) for phenolic-coated heat exchanger system in Bldg 87017.

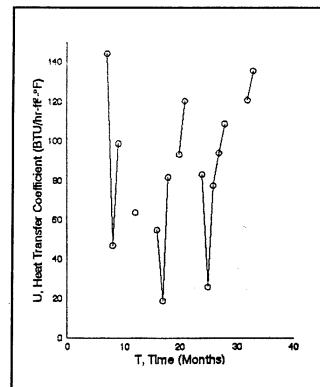
Figure 11. Heat transfer coefficients (U) for phenolic-coated heat exchanger system in Bldg 29006.

Figures 11 and 12 present the overall heat transfer coefficients (U) for the coated heat exchanger systems. These values were calculated using the average monthly values of flow rate (F) and steam (T<sub>s</sub>), cold water (T<sub>c</sub>), and hot water (T<sub>h</sub>) temperatures presented in Figures 3 through 10. Neither Figure 11 nor Figure 12 reveals any degradation. However, note that the heat exchanger was removed from Building 29006 on 28 April 1992 to rehabilitate the coating that had incurred spallation failure after 4.5 years of an estimated 5-year service life.
